Maintenance Tips: Heat Pumps & Condensate Drain Lines

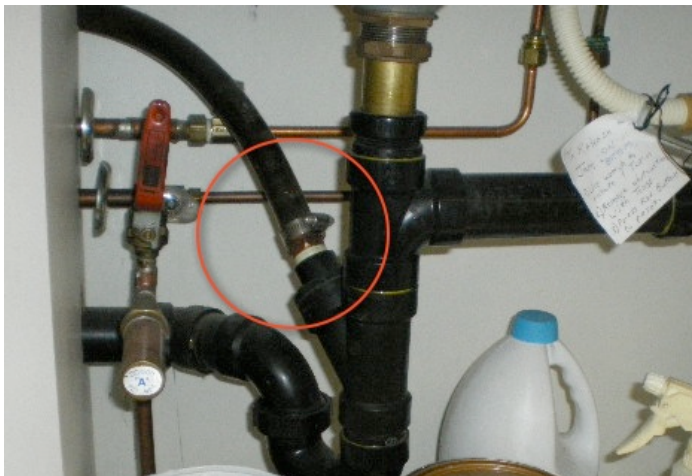
Drain line connecting under kitchen sink

A condensate drain line runs down from the pump to under the kitchen or bathroom sink. It is important to keep this line open and clear otherwise condensate water will overflow onto the ceiling causing leaks, water marks and damage to the drywall.

To check and clear the line, undo the pipe clamp with a screwdriver and slide the hose off the fitting. Ensure there are no food particles or debris in the line. Water should drip from the line freely. Reverse the process to reinstall.

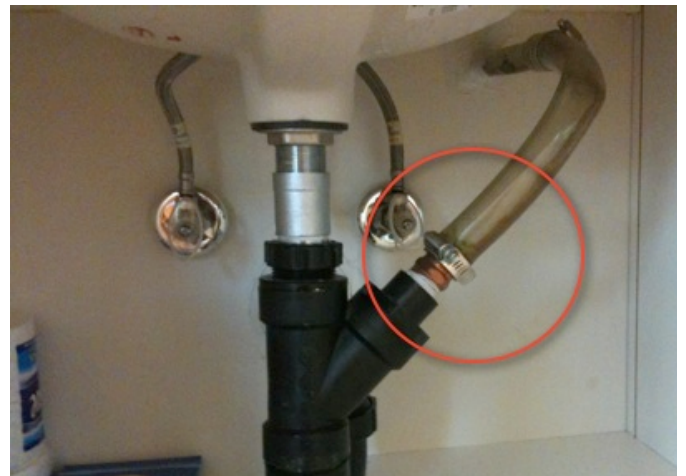
Drain line connecting under bathroom sink
